2 TUBMILL DAM

(ID NO. PA. 488)

4 PHASE I INSPECTION REPORT  
NATIONAL DAM INSPECTION PROGRAM

6 National Dam Inspection Program. Tubmill  
Dam (ID Number PA 488), Ohio River Basin,  
Tubmill Creek, Westmoreland County,  
Pennsylvania. Phase I Inspection Report.

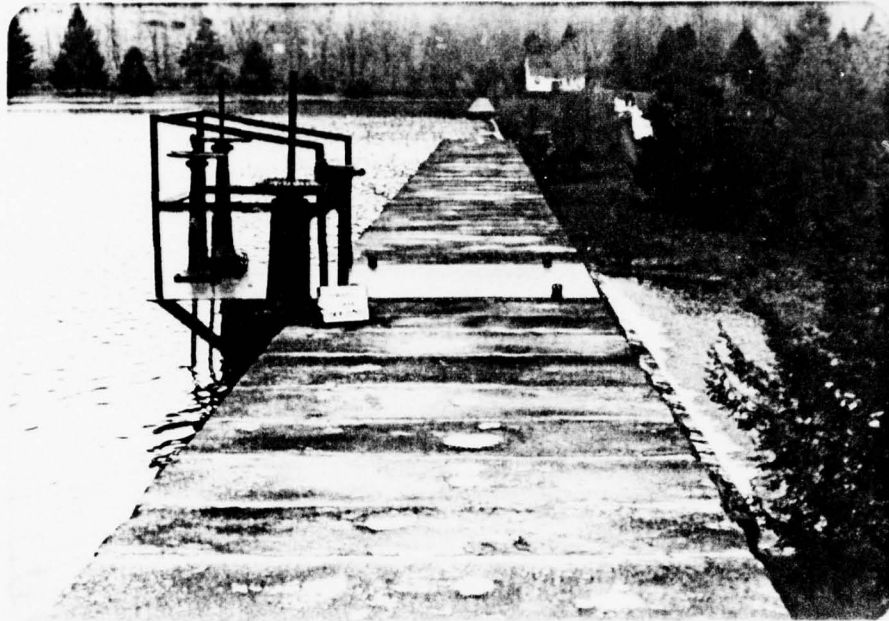
Photograph No. 1  
Crest (looking west).

4. Numerous grout holes were observed on the crest of the dam. The appearance of the grout material suggests that the grouting was done at various times in the past.

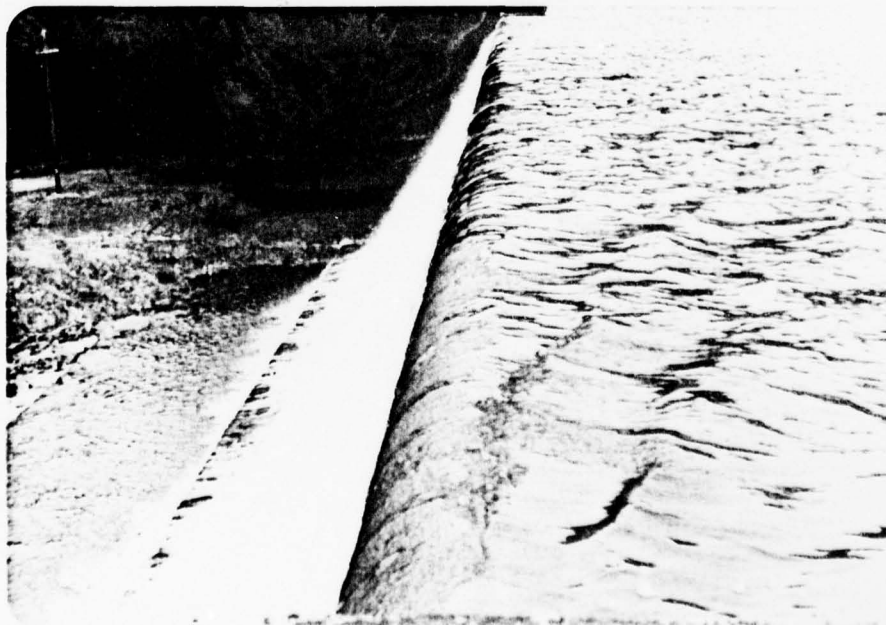
Photograph No. 2  
Spillway.

c. Appurtenant Structures. The spillway crests and plunge pools were examined for deterioration or other signs of distress and obstructions that would limit flow. No signs of apparent distress or erosion were observed.

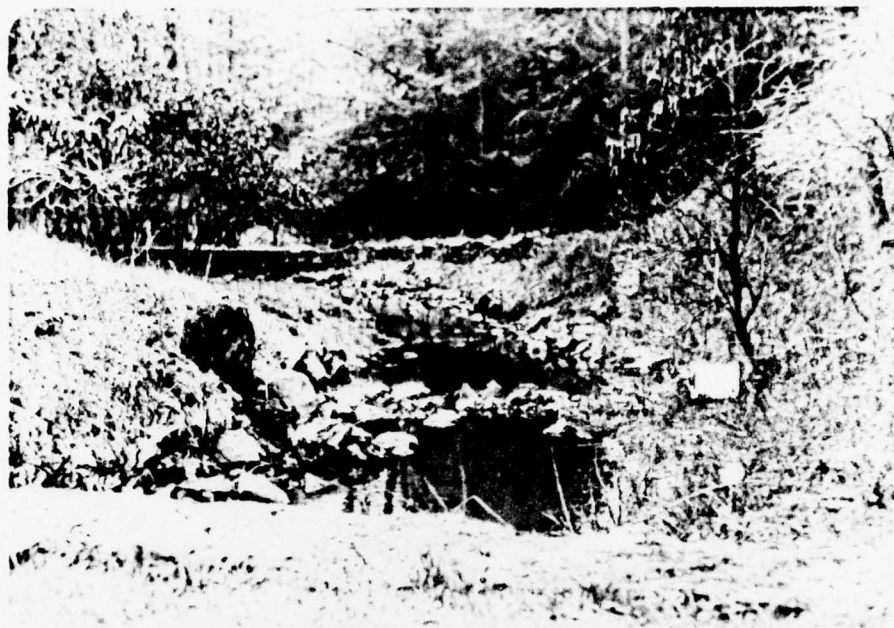
Photograph No. 7

"Blow-off" pipe discharge channel. Seepage noted along channel behind the sign in the photograph.

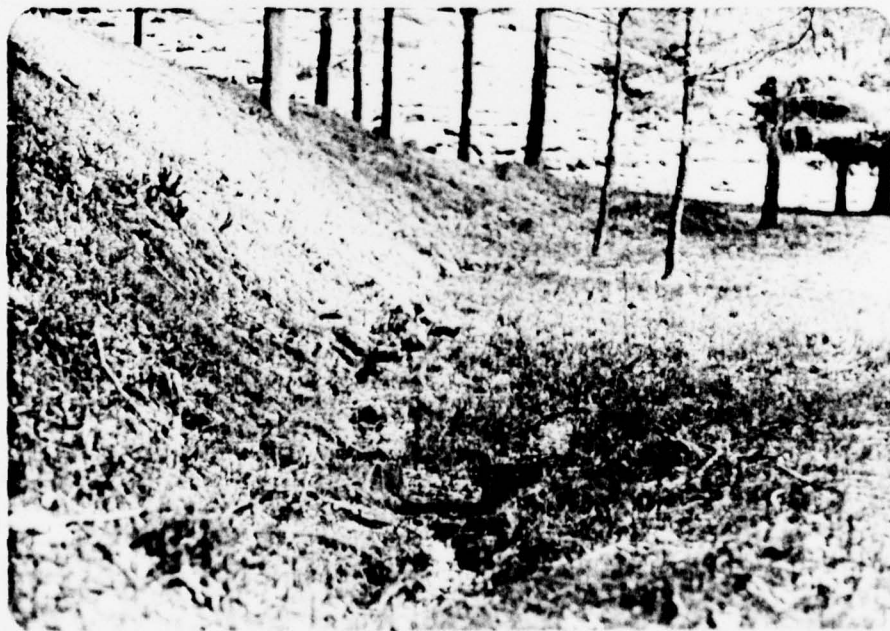
Photograph No. 8

Seepage along right valley wall (see Plate 3). Note old weir in foreground.

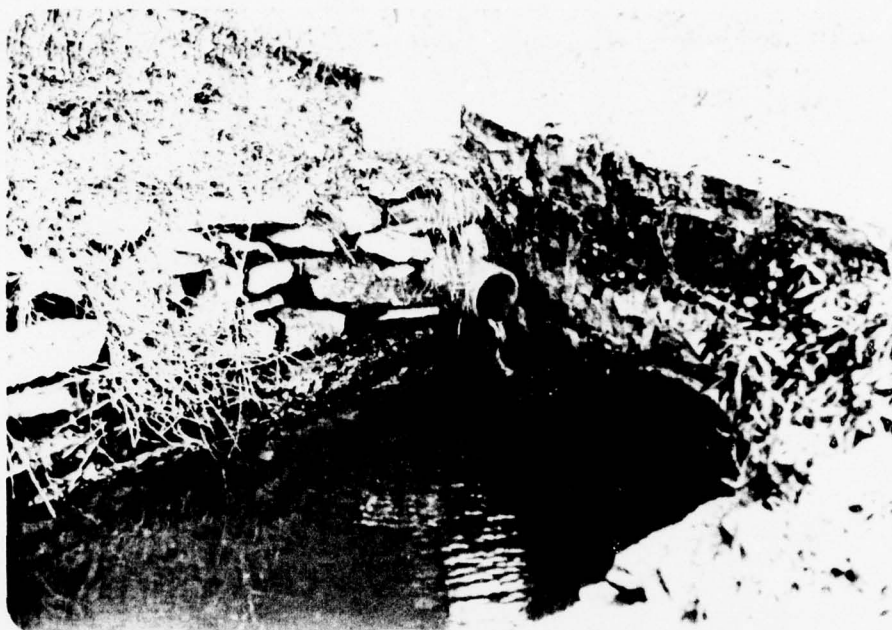
Photograph No. 9

Seepage from the area shown in Photograph No. 8 discharging into "blow-off" pipe discharge channel through 6-inch I.D. clay pipe.

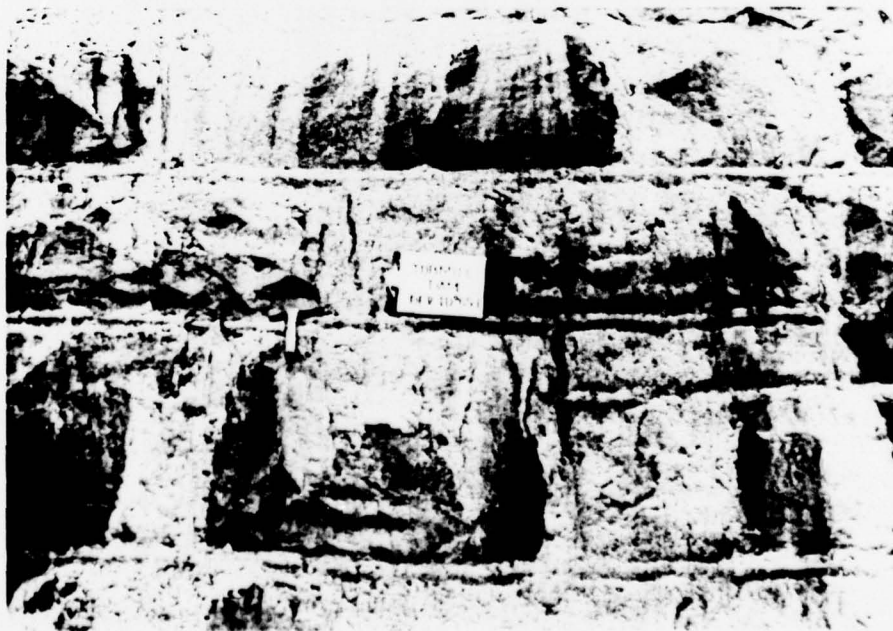
Photograph No. 10

1. The entire downstream face of the dam was found to be wet. The seeps appeared to be coming from near the top of the dam. No concentrated seeps were observed.
2. Wet areas were observed both on the right and left abutments along the toe of the dam. A sewer pipe discharging along the left abutment toe appeared to be contributing significantly to the wetness on that side. No flow away from the wet areas was found.
3. Two wet areas and one concentrated seepage area was found on the right abutment approximately 150 feet downstream from the dam. One wet area was located on a terrace on the right abutment, but no water was

Typical seepage through the dam. Note precipitate buildup.
